**Gregg Properties Co. Ltd.**

**27 Lot Development  
S.W. ¼ Sec. 28-47-1-W5M  
(north of Kerr Cape, Pigeon Lake)**

**Area Structure Plan**

**June, 2002**

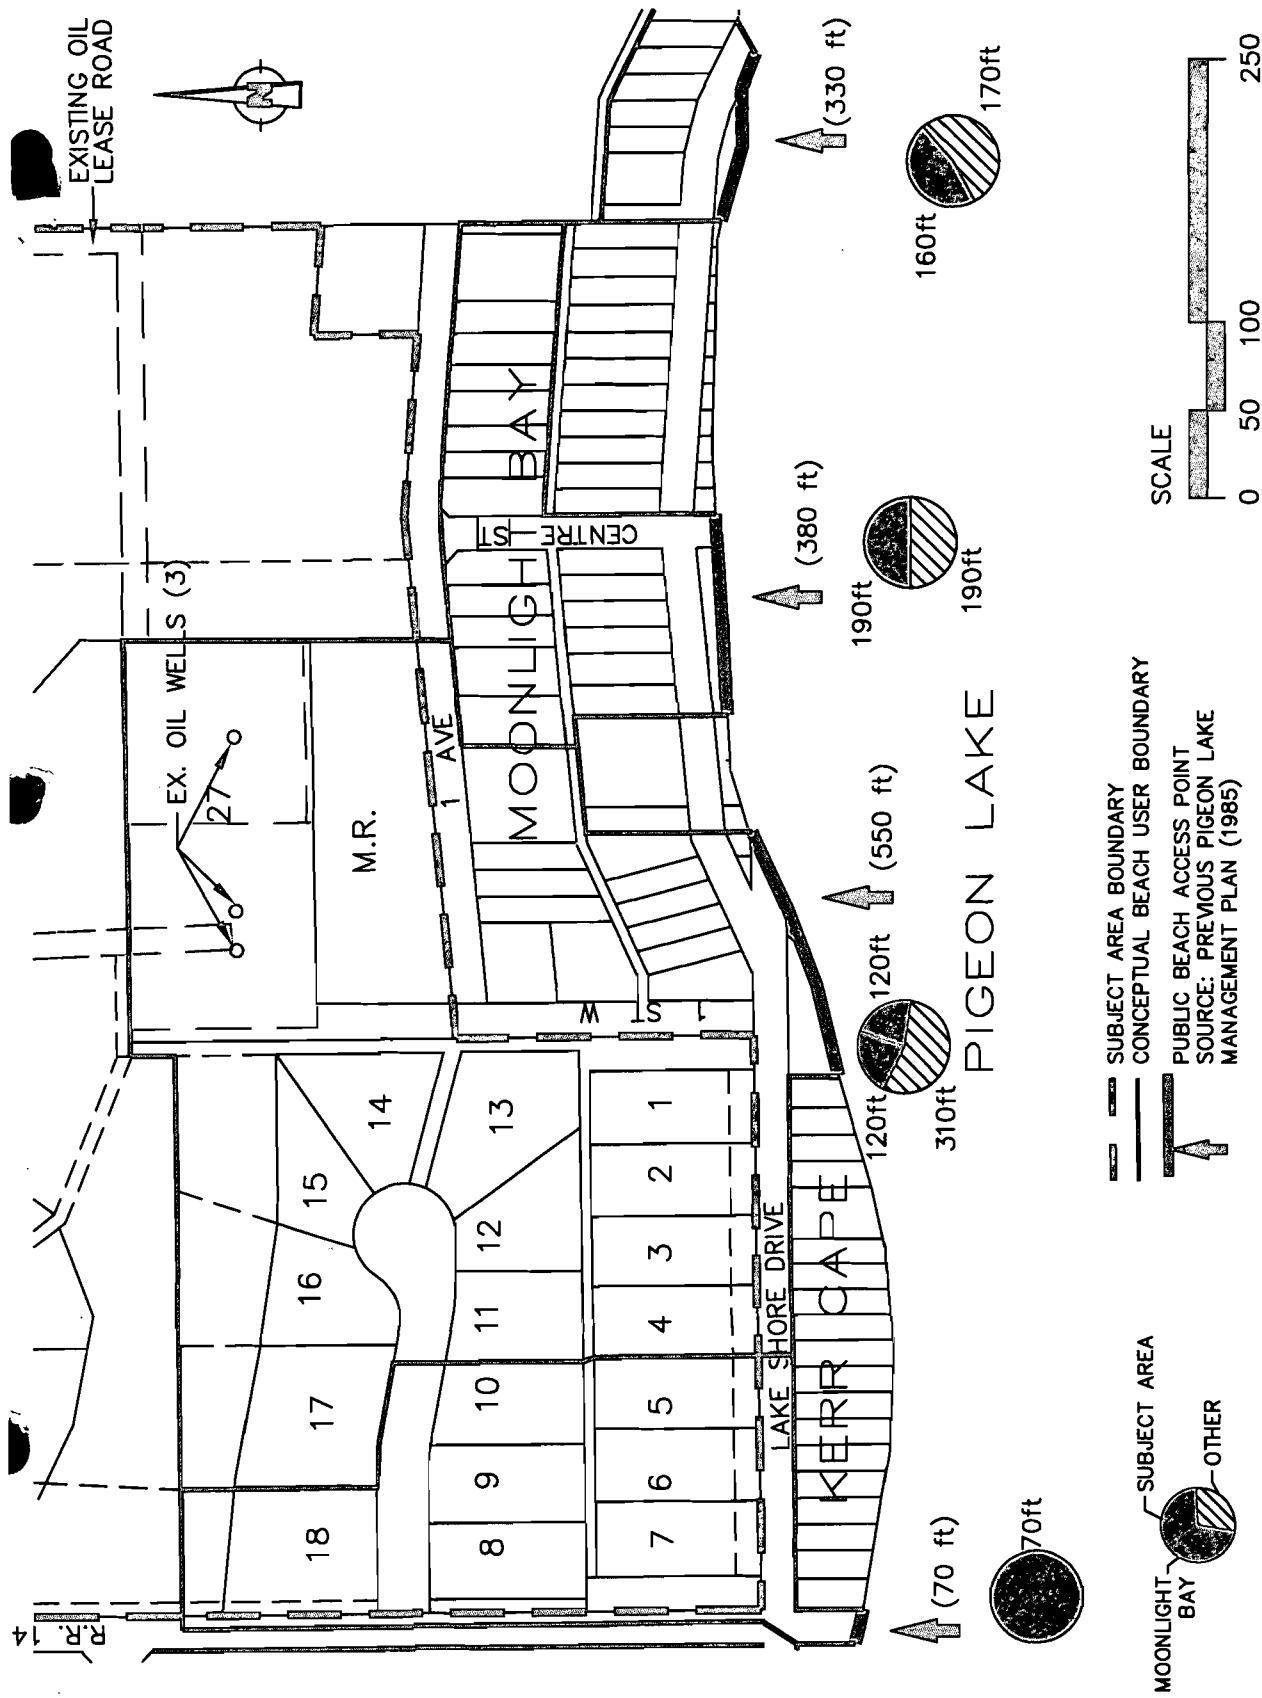
- SUBJECT AREA
- SUBJECT AREA BOUNDARY
- CONCEPTUAL BEACH USER BOUNDARY
- ▲ PUBLIC BEACH ACCESS POINT
- SOURCE: PREVIOUS PIGEON LAKE MANAGEMENT PLAN (1985)

GREGG PROPERTIES CO. LTD. - S.W. 1/4 SEC. 28-47-1-W5M  
AREA STRUCTURE PLAN  
BEACH ACCESS PLAN  
(FOR LOTS WITHIN APPROX. 400m OF THE LAKE)  
FIGURE 4.3 (as amended)

4. THAT the map that is attached to and forms part of this Bylaw be substituted for Figure 4.3 "Beach Access Plan";
5. THAT the words "Summer Village of Sundance Beach," be added after the words "the County," in paragraph 5 of Section 4.3, Lake Access.

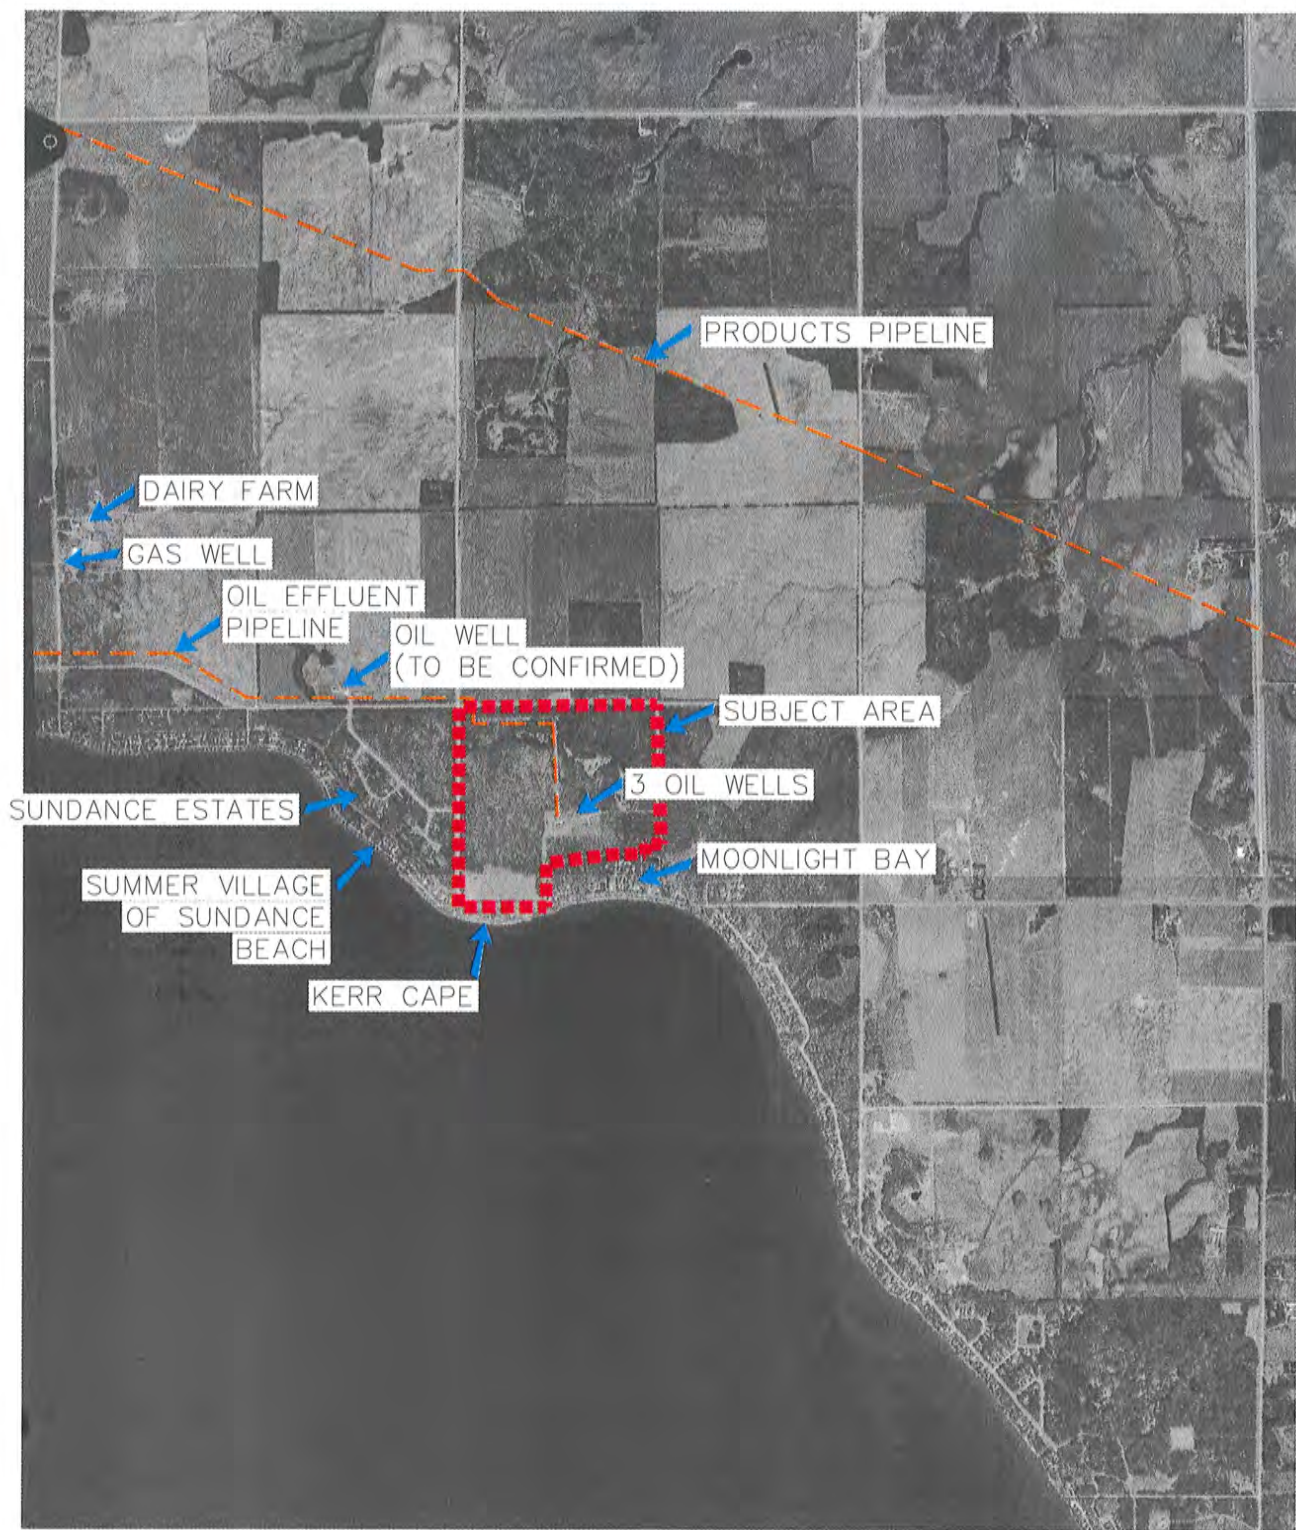
GREGG PROPERTIES CO. LTD.  
S.W 1/4 SEC. 28-47-1-W5M  
AREA STRUCTURE PLAN  
EXISTING LAND USE OVERVIEW PLAN  
FIGURE 2.1

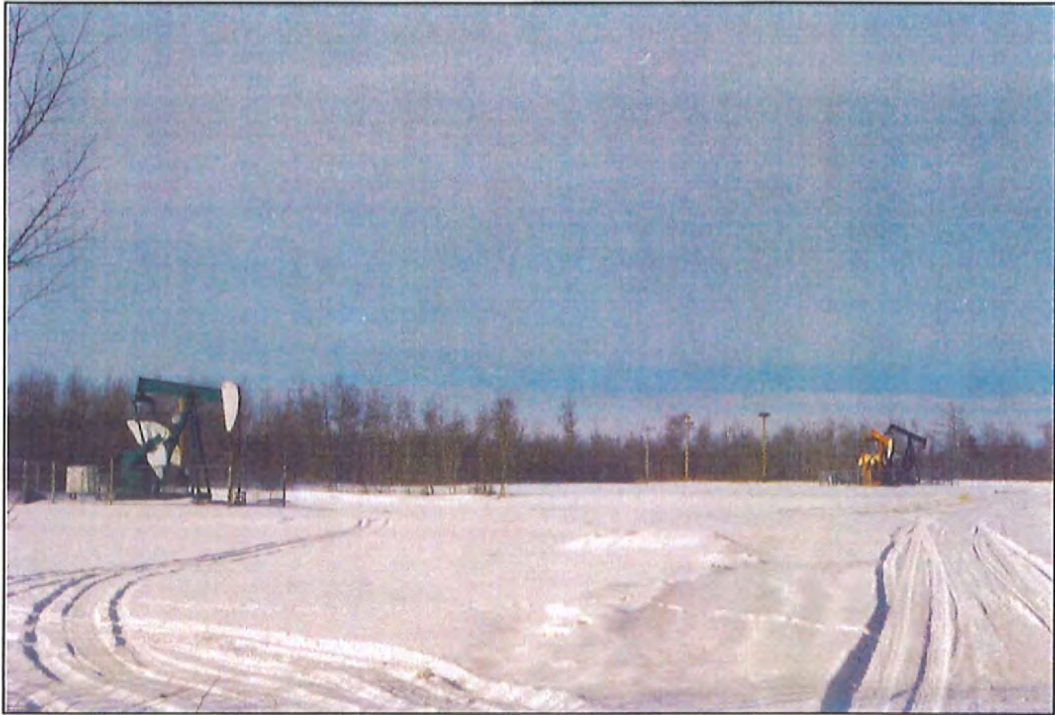
**Photo 1.** Anthropogenic habitat class showing three active wellheads. Osprey nest in the distance.
